Manhole Inspection Summary

Manhole # S49I__003MH

Insp Date: **4/1/08 8:44 AM**

Location Address: **502 S Millton Av**

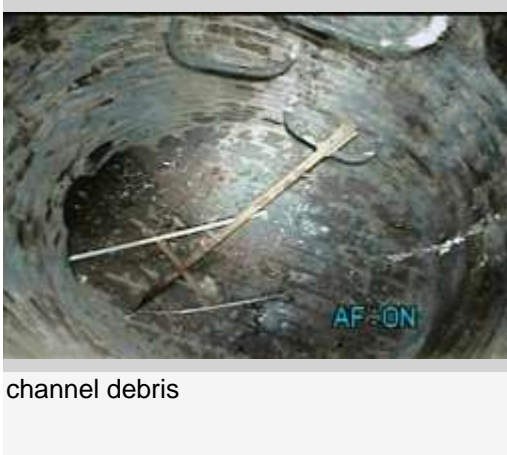
Miscellaneous

channel debris

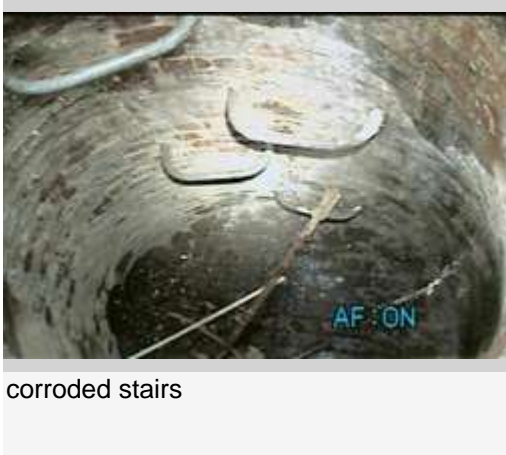
Defect 1

Count: **4** Missing: **0** ☒ **Corroded**

corroded stairs

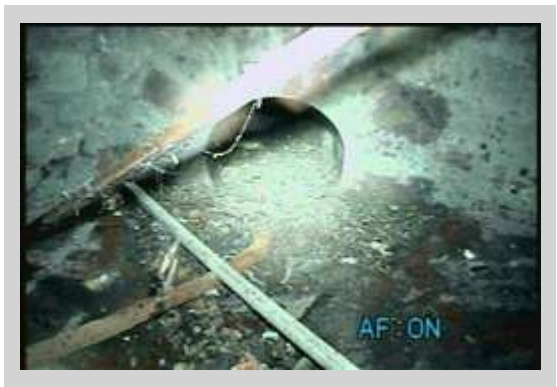
12 O'Clock Outflow

8 in. Circular Gravity Sewer
Pipe Out @ 12 O'Clock

Infiltration: None Pipe Seal Cond: Unknown
